### Inspection Report

#### Minerals Regulatory Program

<b>Mine Name:</b> Browns Canyon Rock Quarry	<b>Permit Number:</b> M/043/0017
<b>Operator Name:</b> Castle Valley Stone, LLC.	<b>Inspection Date:</b> September 08, 2010
<b>Inspector(s):</b> L Heppler	<b>Time:</b> 9:00 AM
<b>Other Participants:</b> Operators Representative	<b>Mine Status:</b> Active

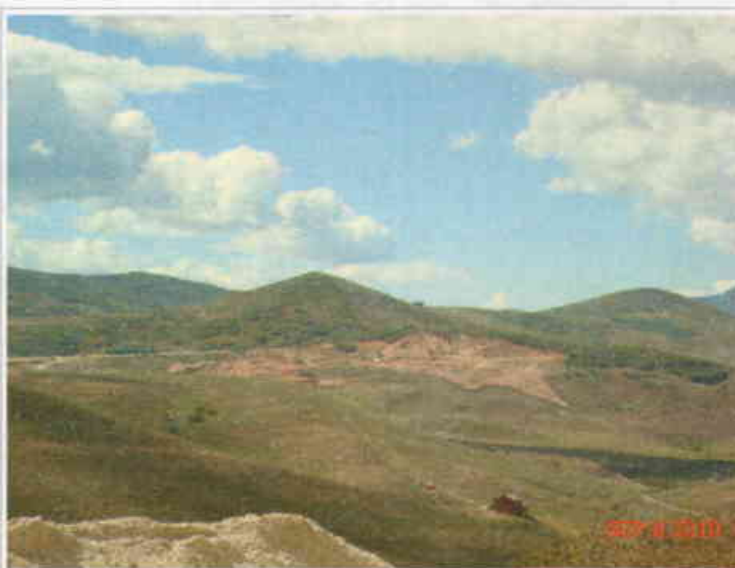
**Inspection Summary:** At the time of the inspection, this mine site was operated by Develon Worth. Footprint at the time of inspection appeared to have expanded to the west into the scrub oak. There is a landslide/debris flow that has enlarged the foot print to the north.

Overview of the site – note debris flow

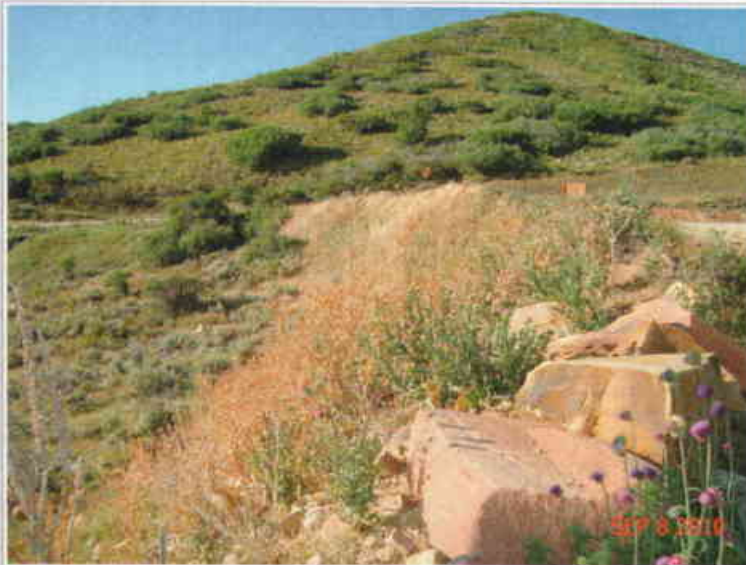
Access road – note weeds

**Conclusions and Recommendations:** Permit NOI needs to be updated based on current disturbance on the ground and the Operators plan. Bond was increased when the transferred was completed, Weeds need to be controlled, as shown in attached photos. OGM to continue annual inspections and monitor the site when in the area.

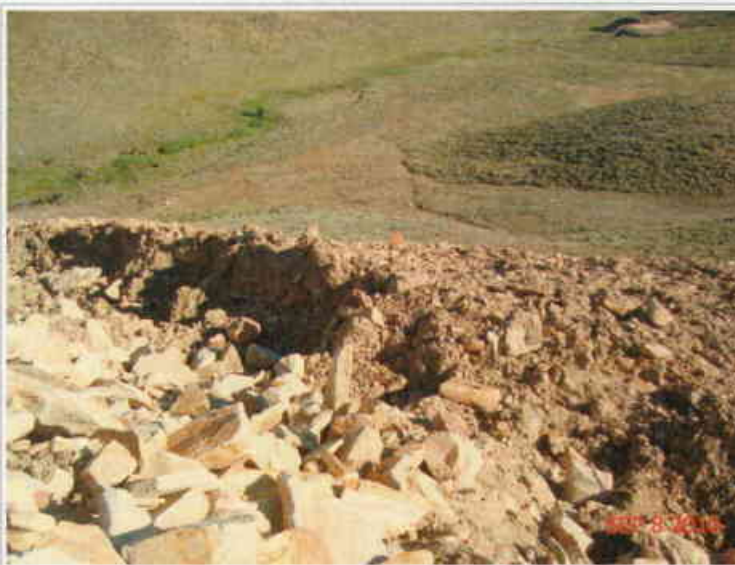
Debris flow – note fine grained soils

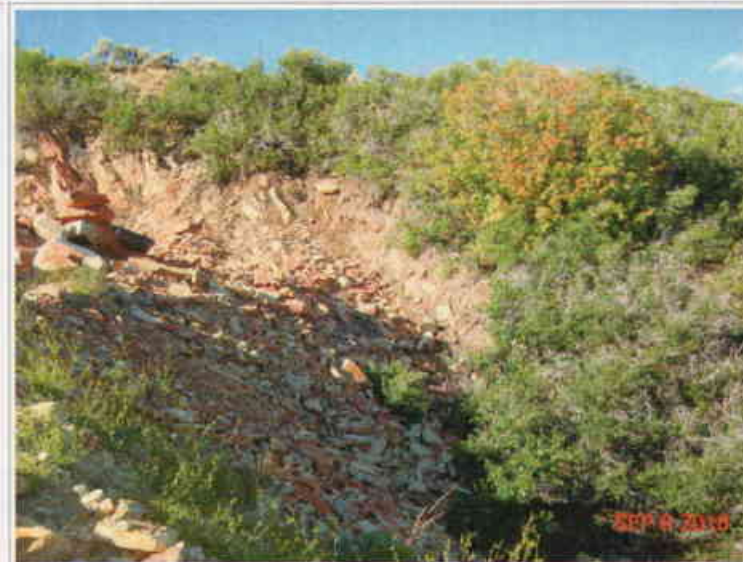
Area of west expansion
